COBALT® Exposed Side Sensor Flush Valve Exploded View

Part No. 103582 : 3000 : A

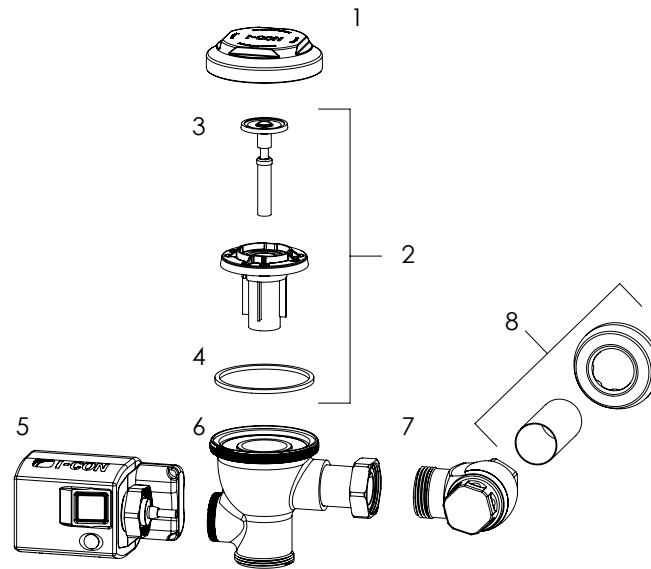
Label	Part Variant	Part Number	Description
1	-	100692	I-CON Cap, Chrome-Plated Brass
2	A	101427 : 0.125	ProLAST® Manual Rebuild Kit, Urinal - 0.125 gpf / 0.5 Lpf
2	B	101427 : 0.25	ProLAST® Manual Rebuild Kit, Urinal - 0.25 gpf / 0.9 Lpf
2	C	101427 : 0.5	ProLAST® Manual Rebuild Kit, Urinal - 0.5 gpf / 1.9 Lpf
2	D	101427 : 1.0	ProLAST® Manual Rebuild Kit, Urinal - 1.0 gpf / 3.8 Lpf
2	E	101427 : 1.1	ProLAST® Manual Rebuild Kit, Water Closet - 1.1 gpf / 4.2 Lpf
2	F	101427 : 1.28	ProLAST® Manual Rebuild Kit, Water Closet - 1.28 gpf / 4.8 Lpf
2	G	101427 : 1.6	ProLAST® Manual Rebuild Kit, Water Closet - 1.6 gpf / 6.0 Lpf
2	H	101427 : 2.4	ProLAST® Manual Rebuild Kit, Water Closet - 2.4 gpf / 9.0 Lpf
2	I	101427 : 3.5	ProLAST® Manual Rebuild Kit, Water Closet - 3.5 gpf / 13.2 Lpf
3	-	100989	Trip Mechanism
4	-	100999	Square-Profile O-Ring
5	-	103557	Side-Mount Sensor Actuator
6	-	101063	Valve Body - Chrome-Plated Brass

7	A	100993 : 1" : CP Brass	1" (25mm) Control Stop - Screwdriver Stop, Chrome-Plated Brass
7	B	100993 : 3/4" : CP Brass	3/4" (19mm) Control Stop - Screwdriver Stop, Chrome-Plated Brass
8	A	102548	1" (25mm) Sweat Solder Kit - 6" Tube Cover, Wall Flange with Set Screw, and Threaded Adapter
8	B	102549	3/4" (19mm) Sweat Solder Kit - 4" Tube Cover, Wall Flange with Set Screw, and Threaded Adapter
